Debris/Ice/TPS Assessment And Photographic Analysis For Shuttle Mission STS-28R

September 1989

DEBRIS/ICE/TPS ASSESSMENT
AND
PHOTOGRAPHIC ANALYSIS
OF
SHUTTLE MISSION STS-28R

AUGUST 8, 1989

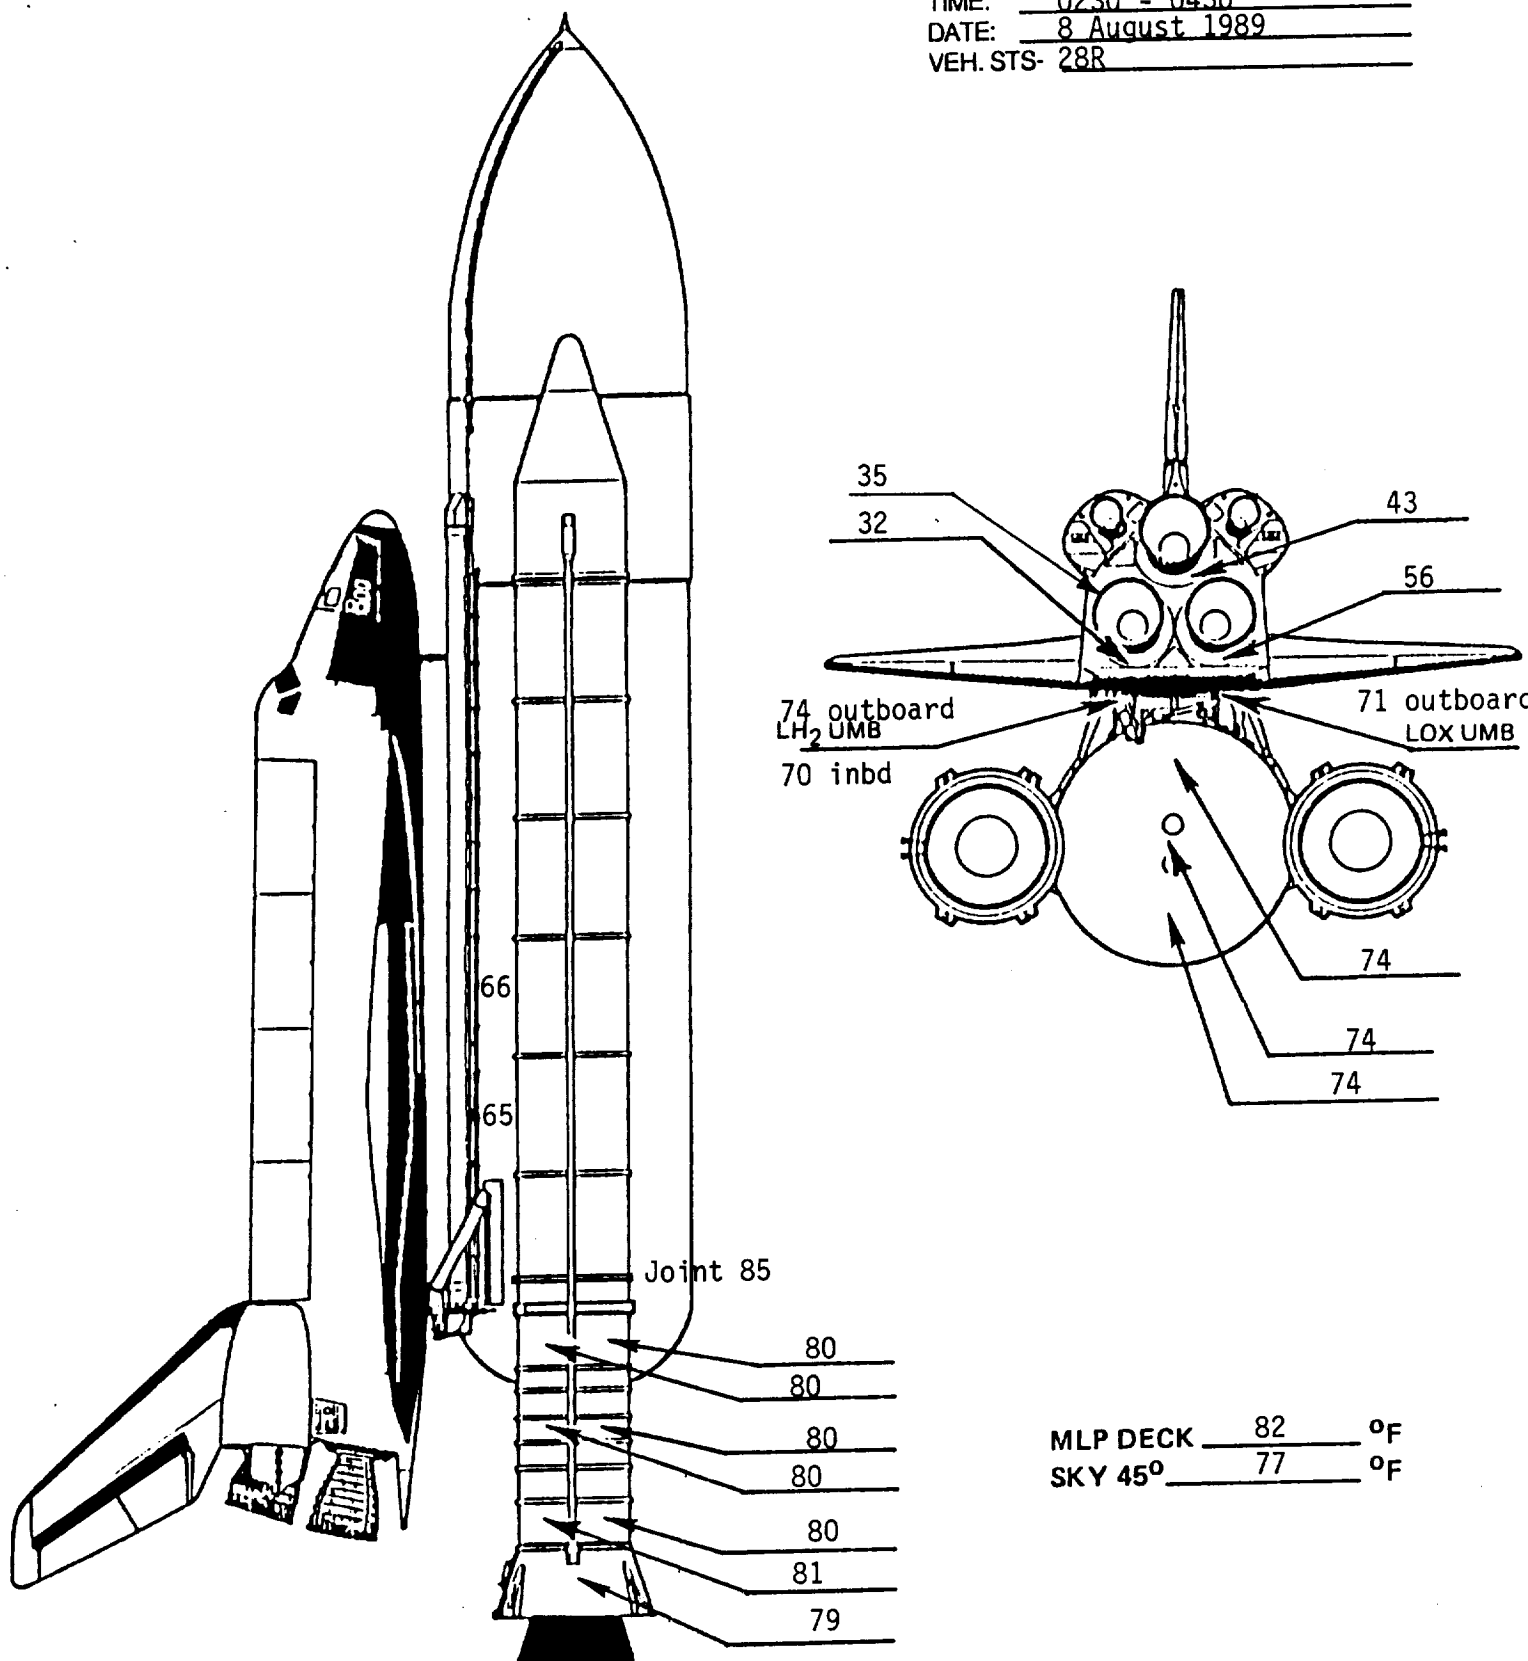
FIGURE 2. INFRA RED SCANNER SSV SUMMARY DATA

MLP DECK 82 °F
 SKY 45° 77 °F

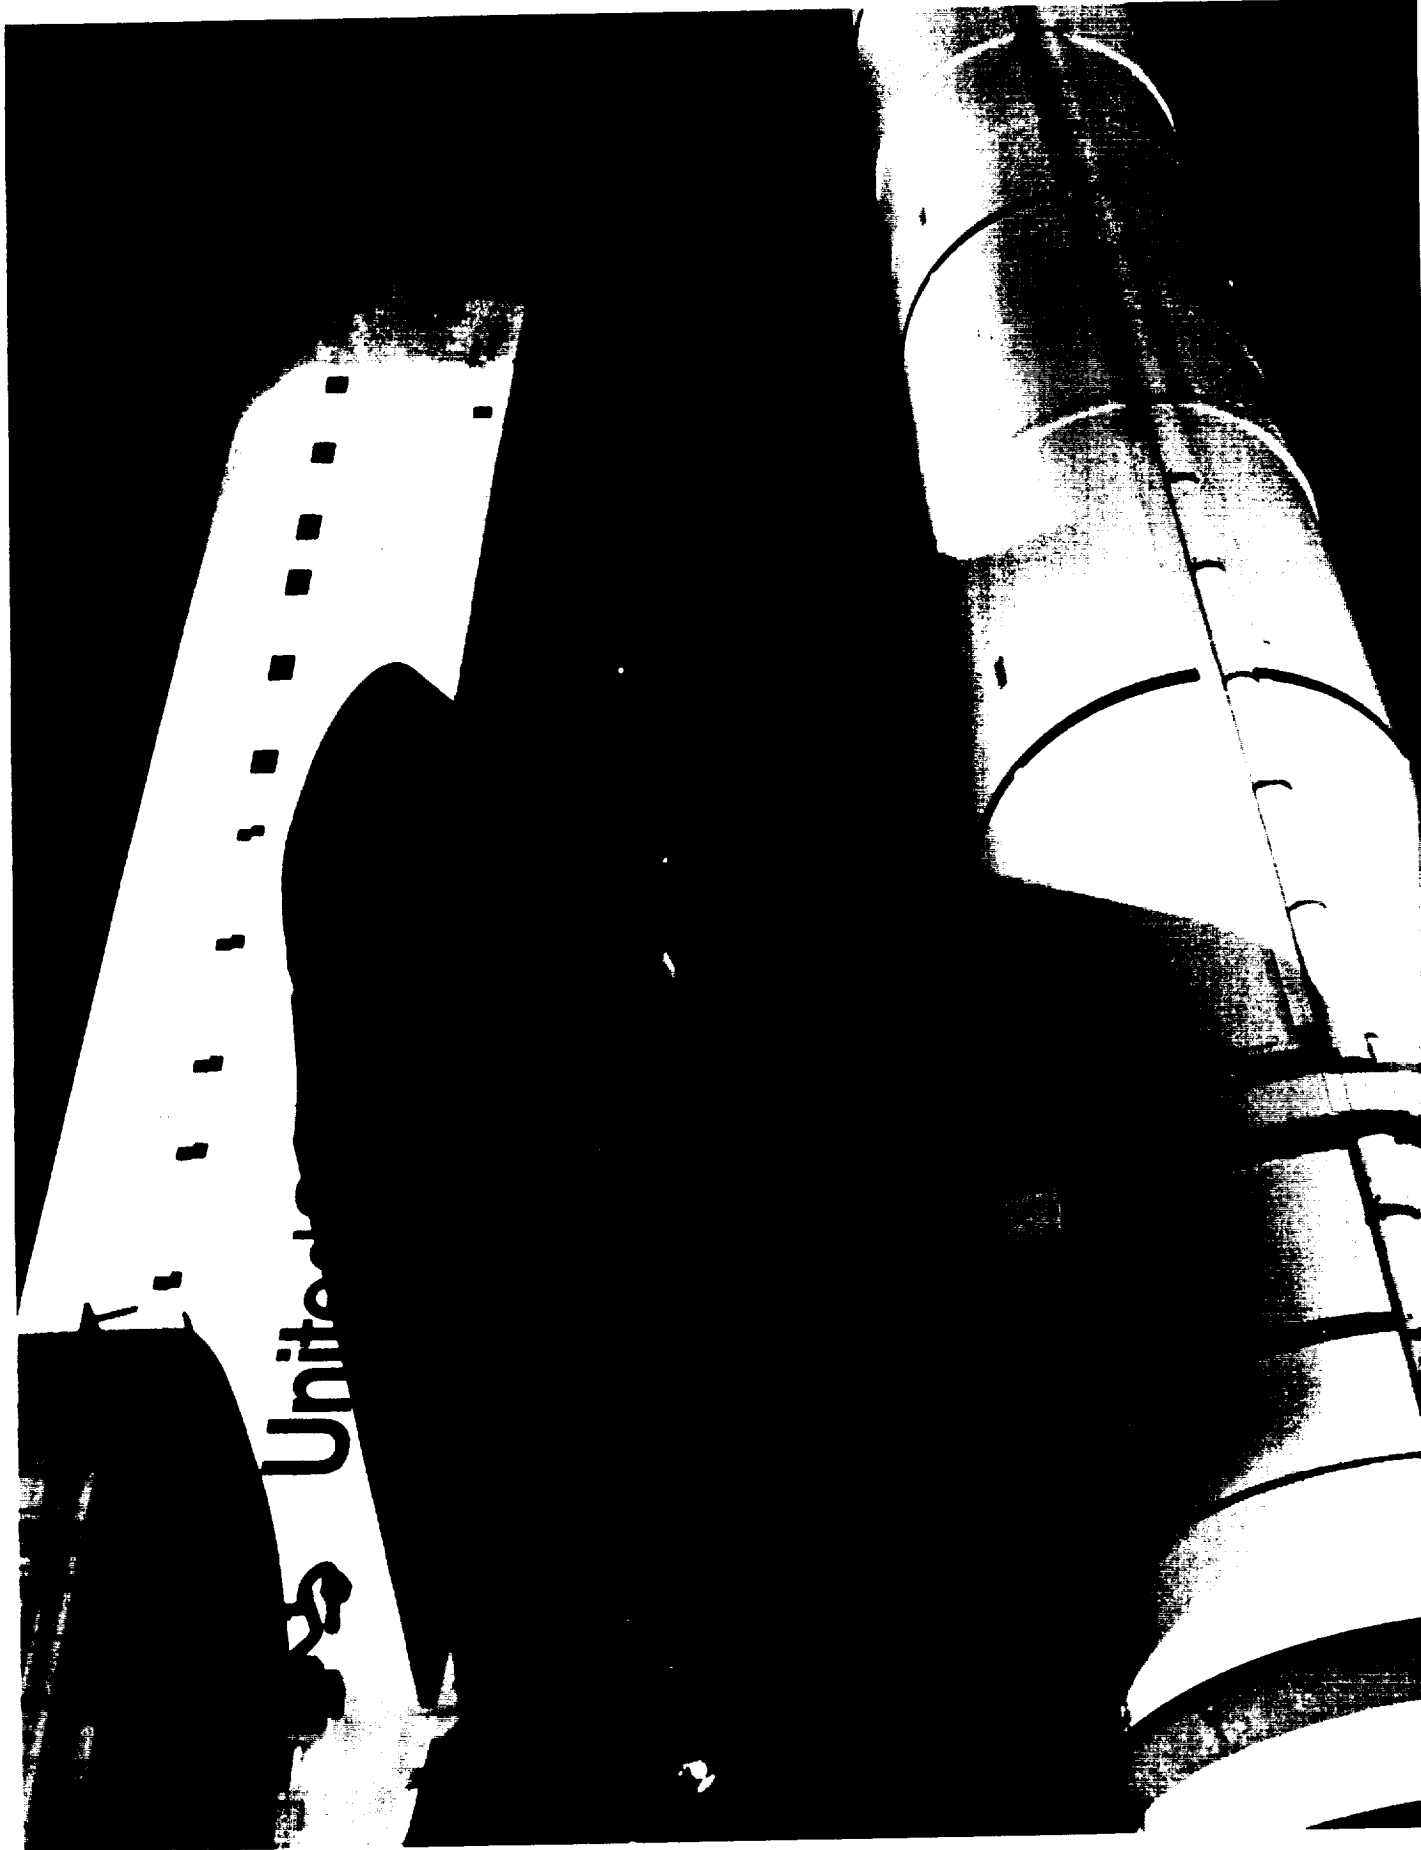
NO TPS ACREAGE ANOMALIES DURING CRYOLOAD. NOTE RH SOLID ROCKET
BOOSTER GEI INSTALLATIONS AND CABLE RUNS.

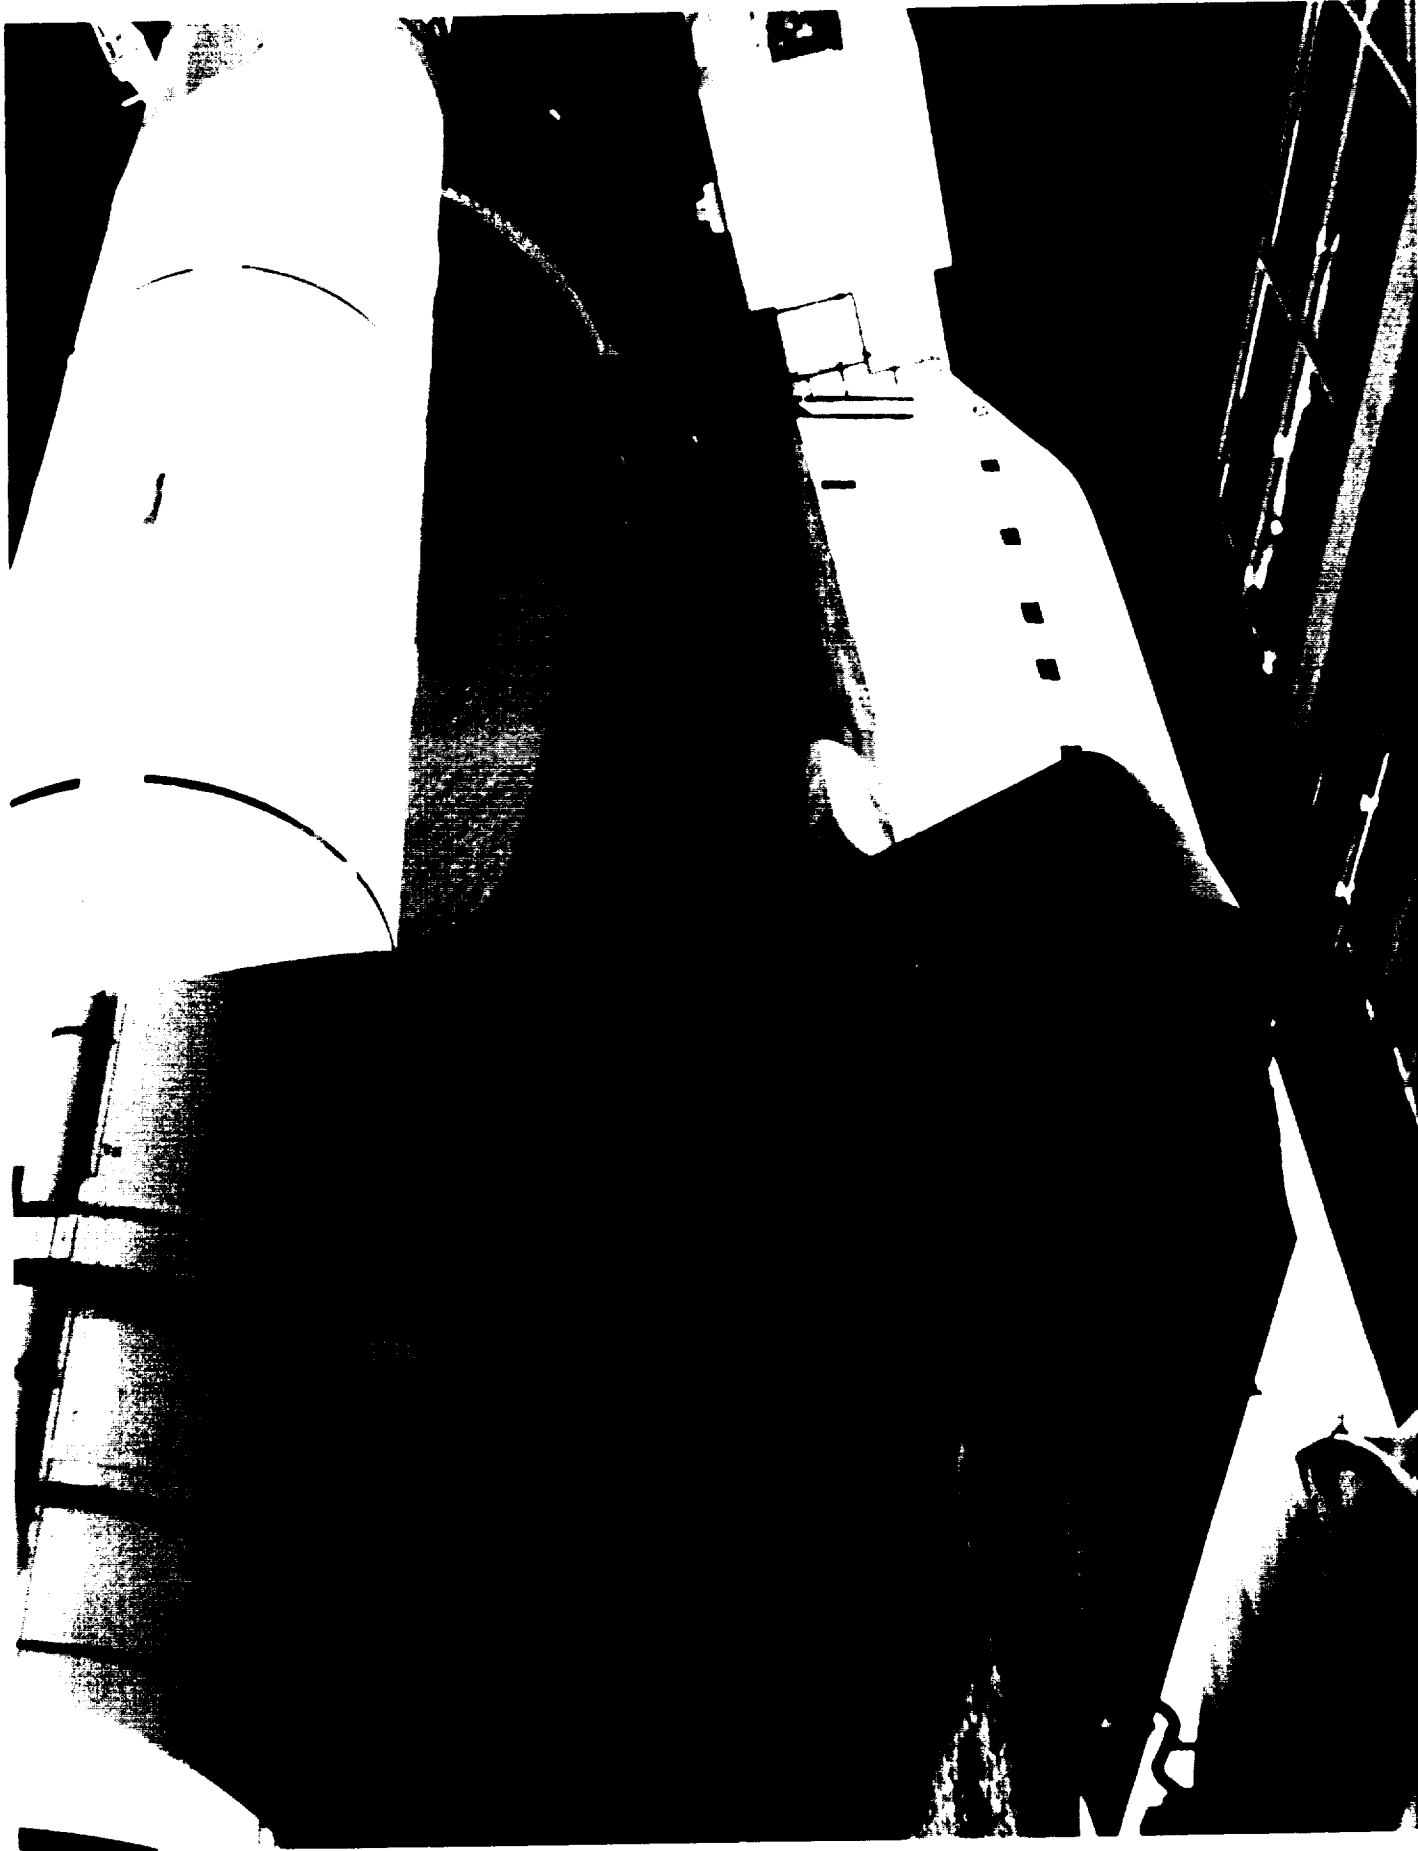
NO ICE/FROST ACCUMULATION ON +Z SIDE TPS ACREAGE

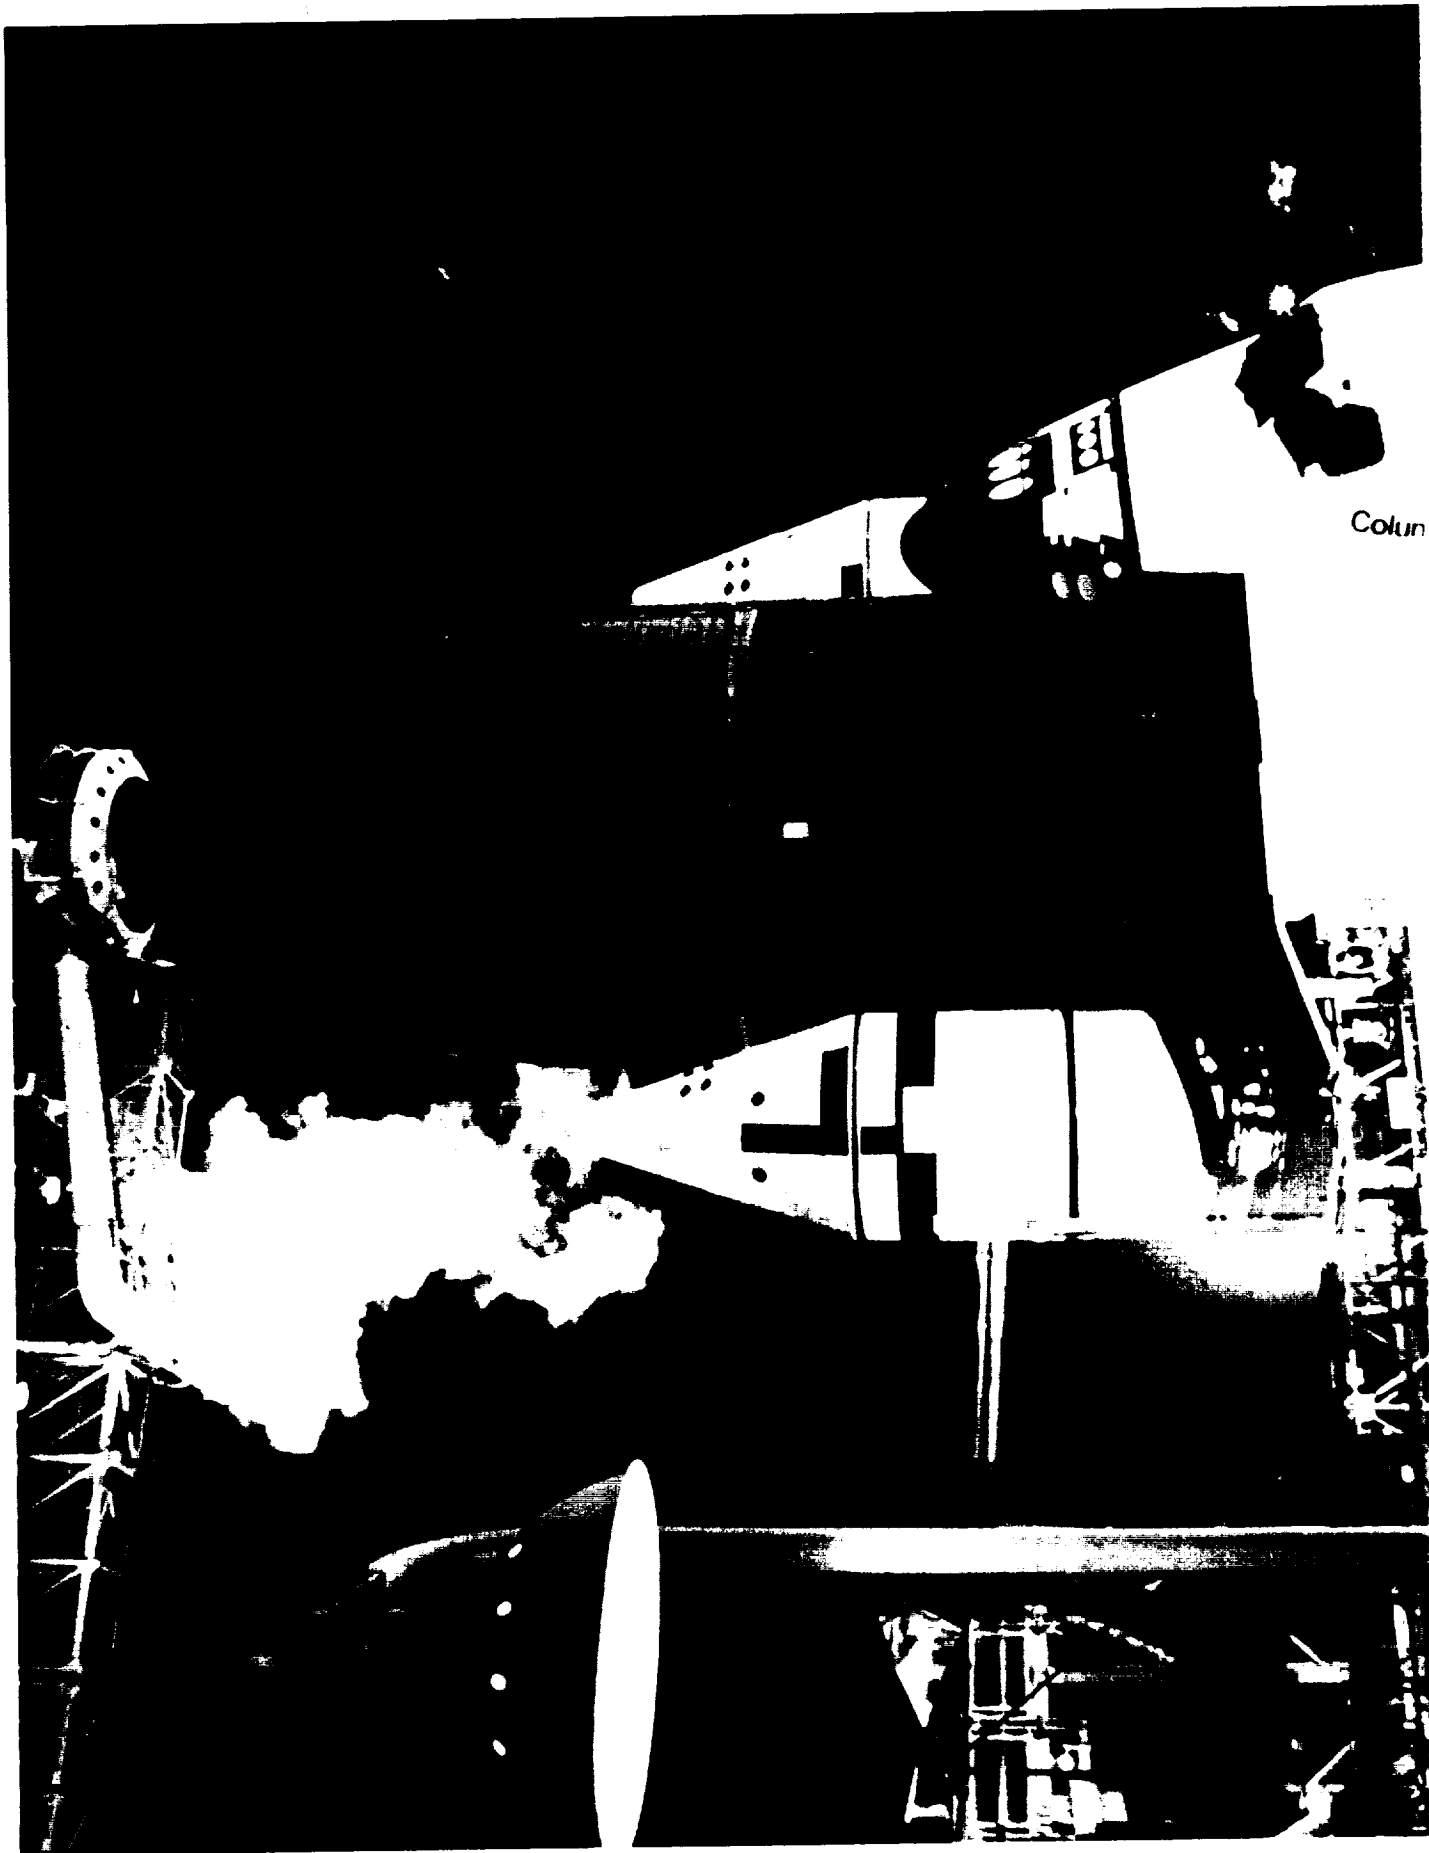
CONDENSATE, BUT NO ICE/FROST ACCUMULATION, WAS PRESENT ON LO2
TANK AFTER CRYOLOAD

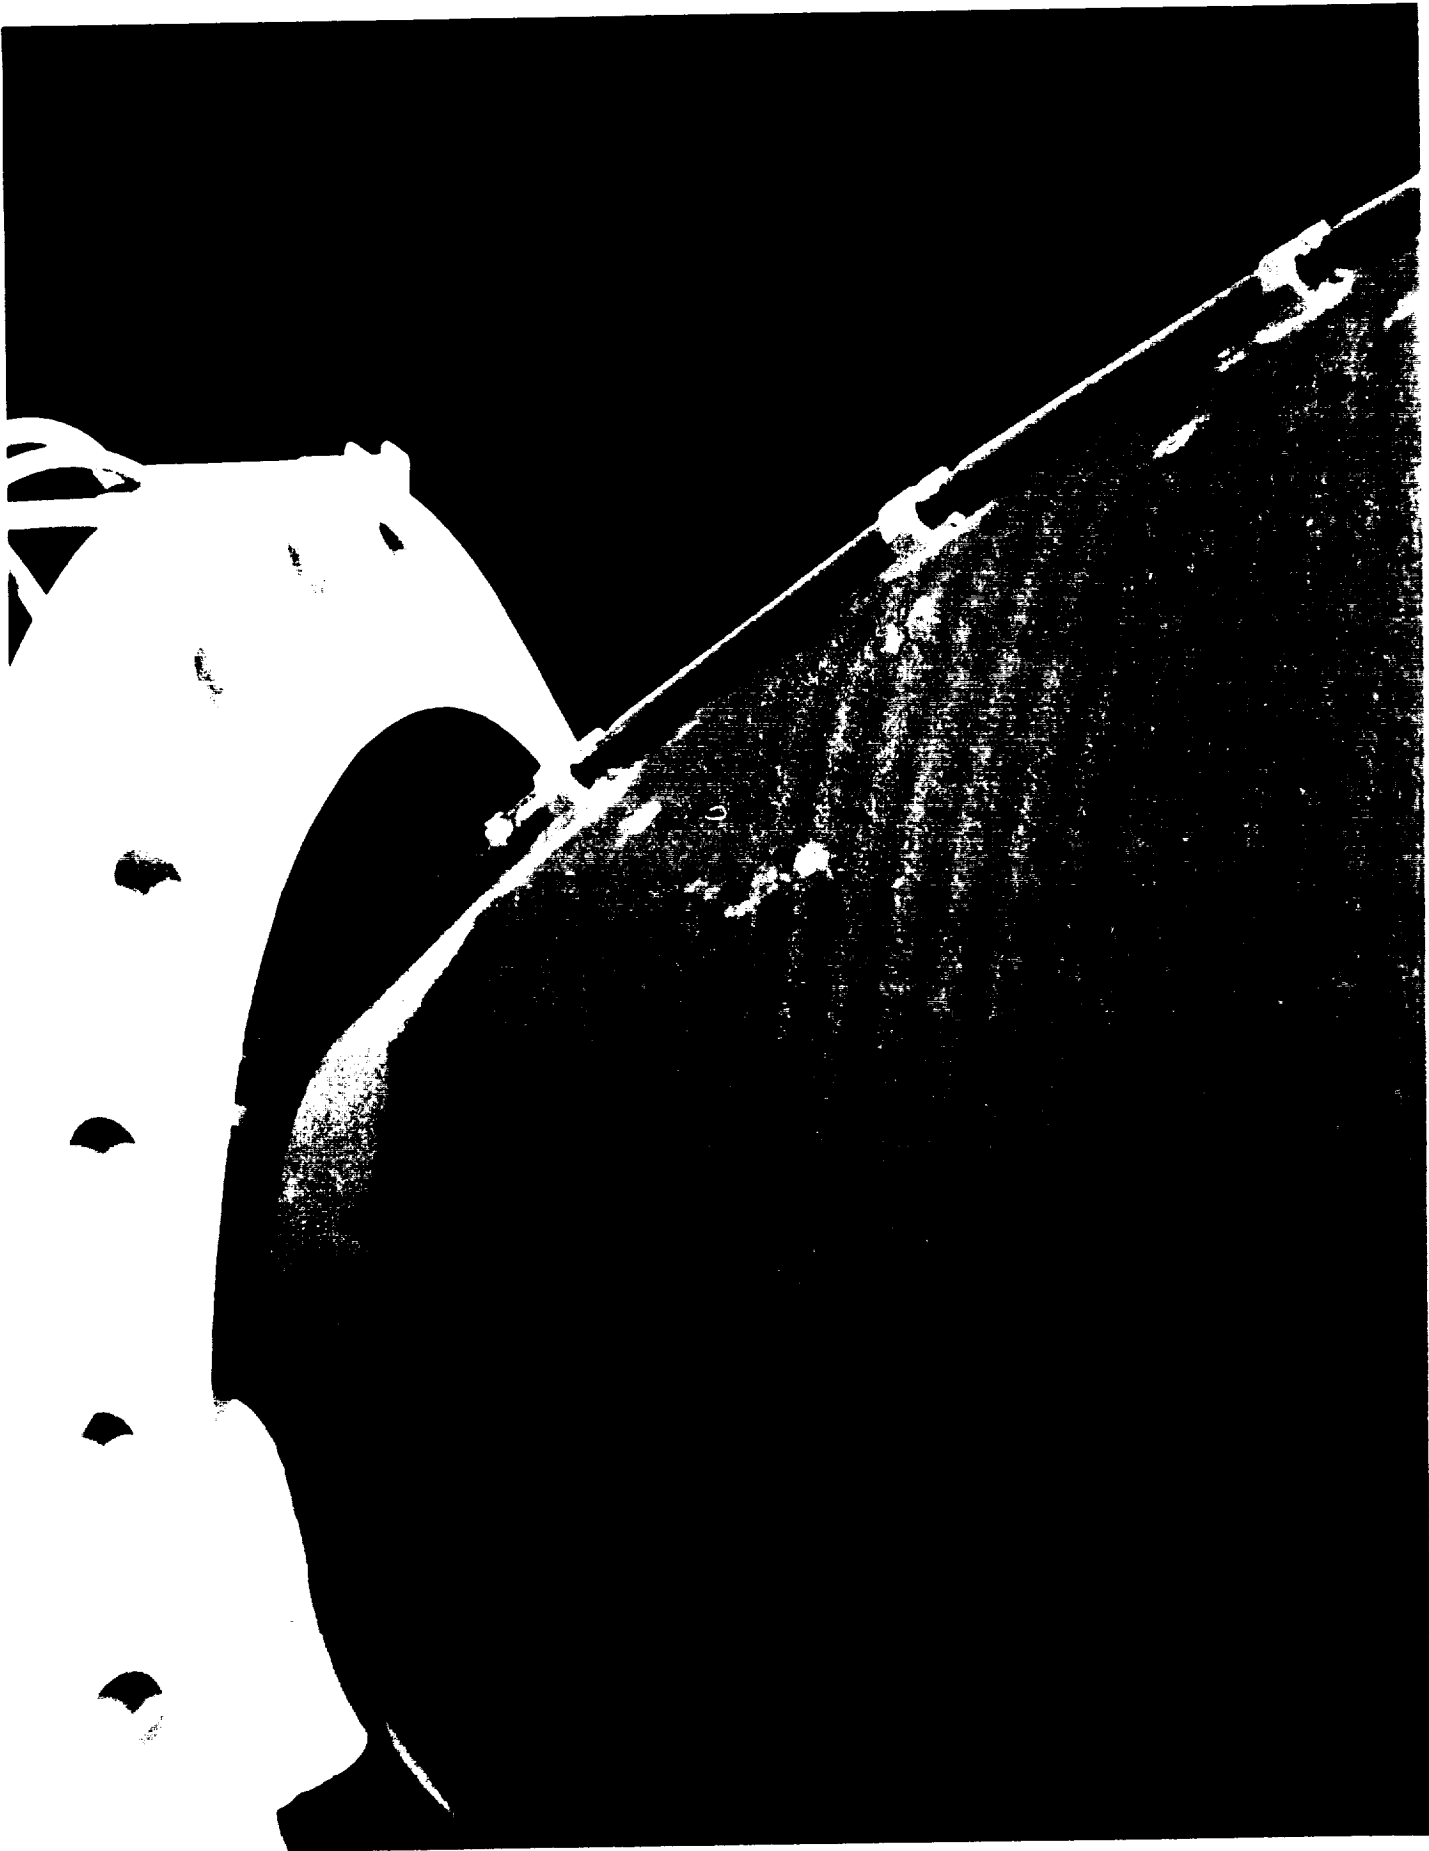
ET TUMBLE VALVE COVER WAS CONFIGURED FOR FLIGHT. NO LEAKAGE
FROM THE GOX VENT SEAL WAS OBSERVED.

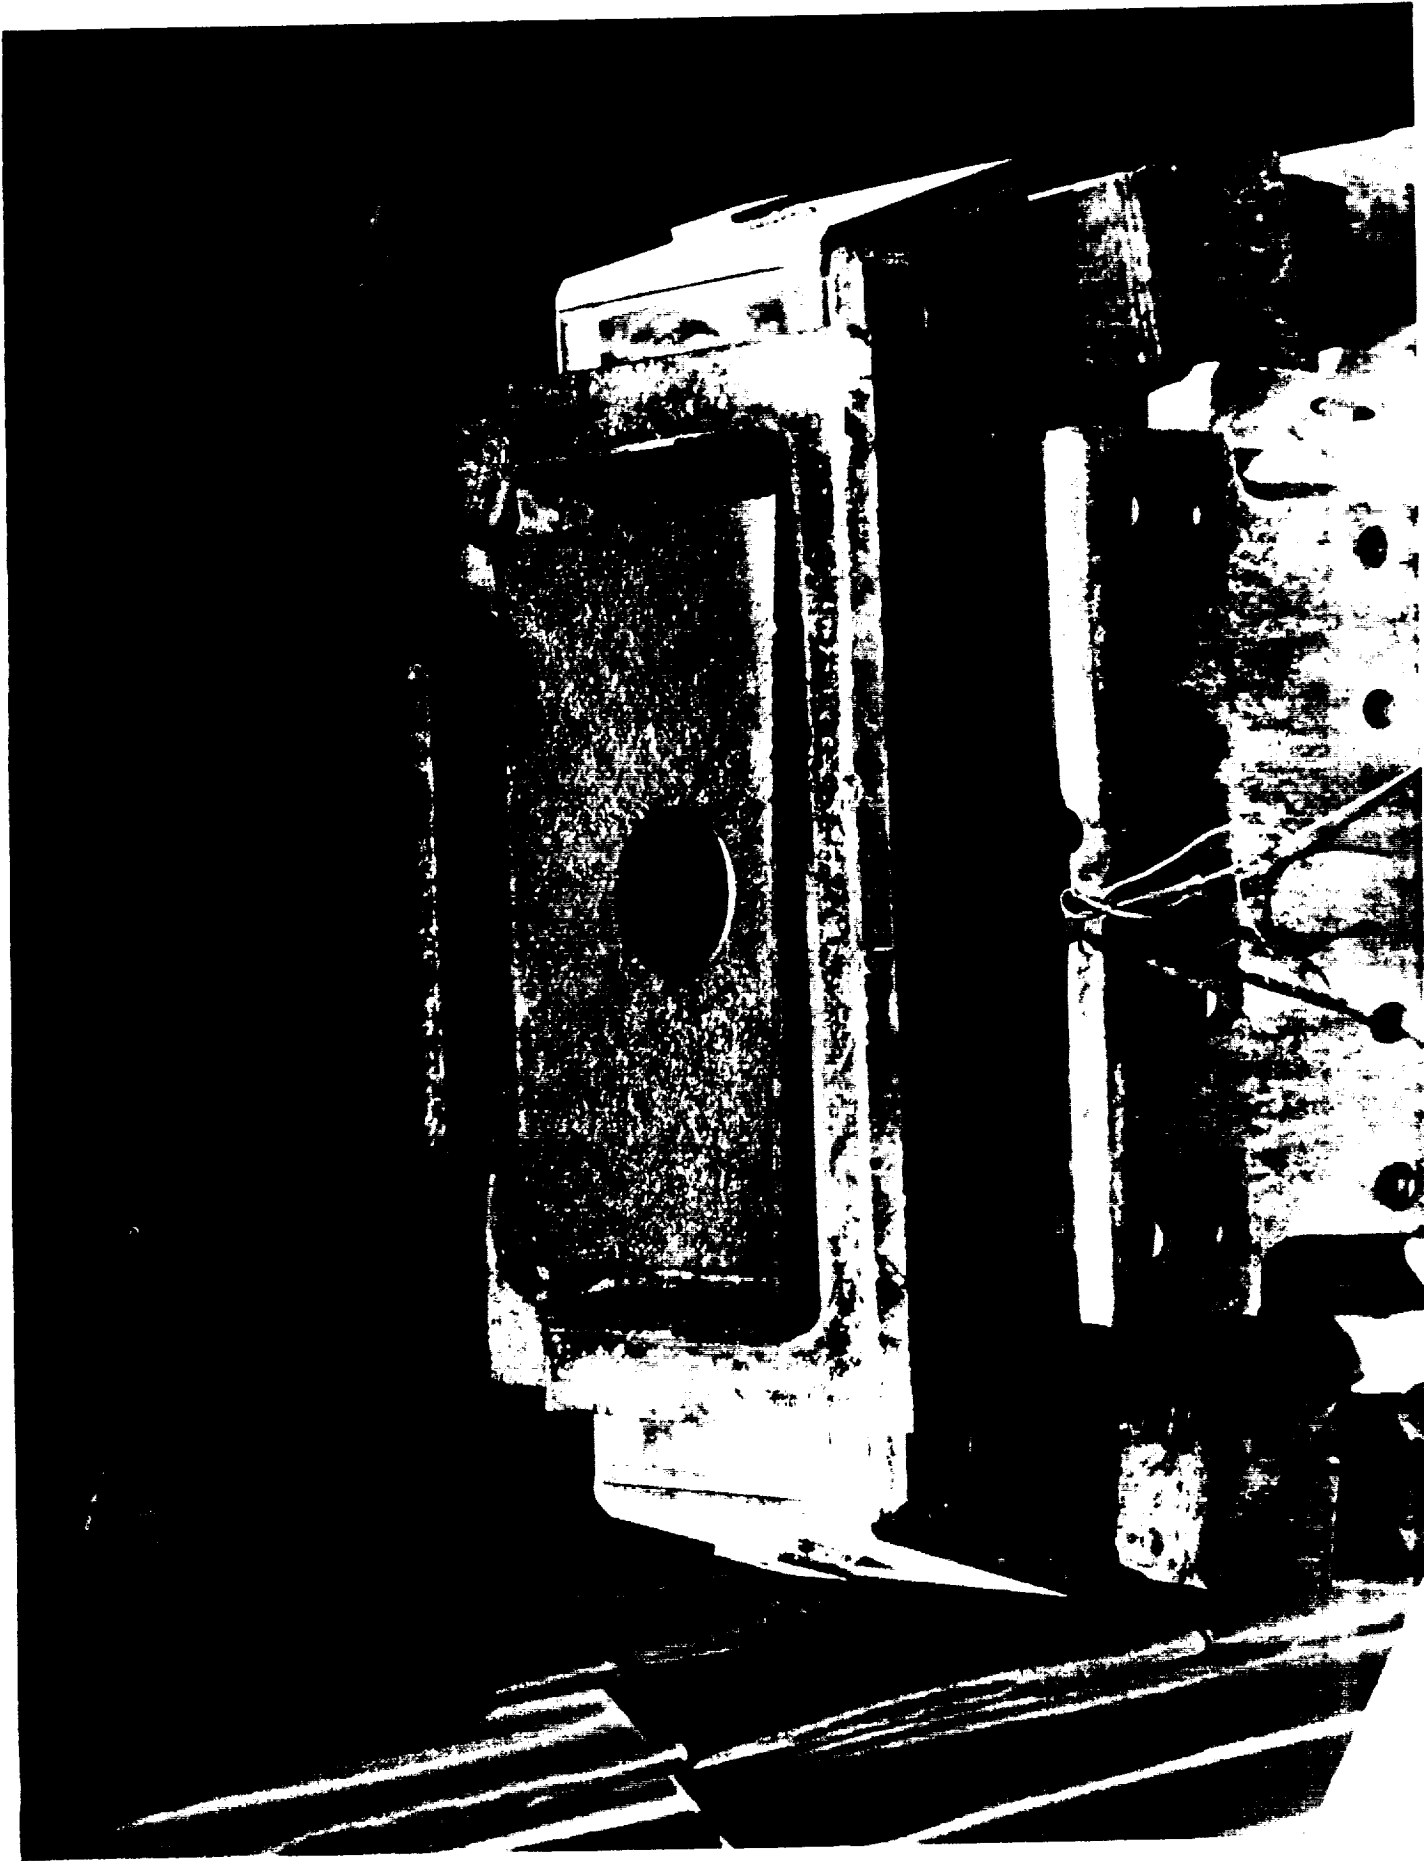
SOUTH HDP SHIM SIDEWALL MATERIAL DEBONDED FROM THE HDP SHOE

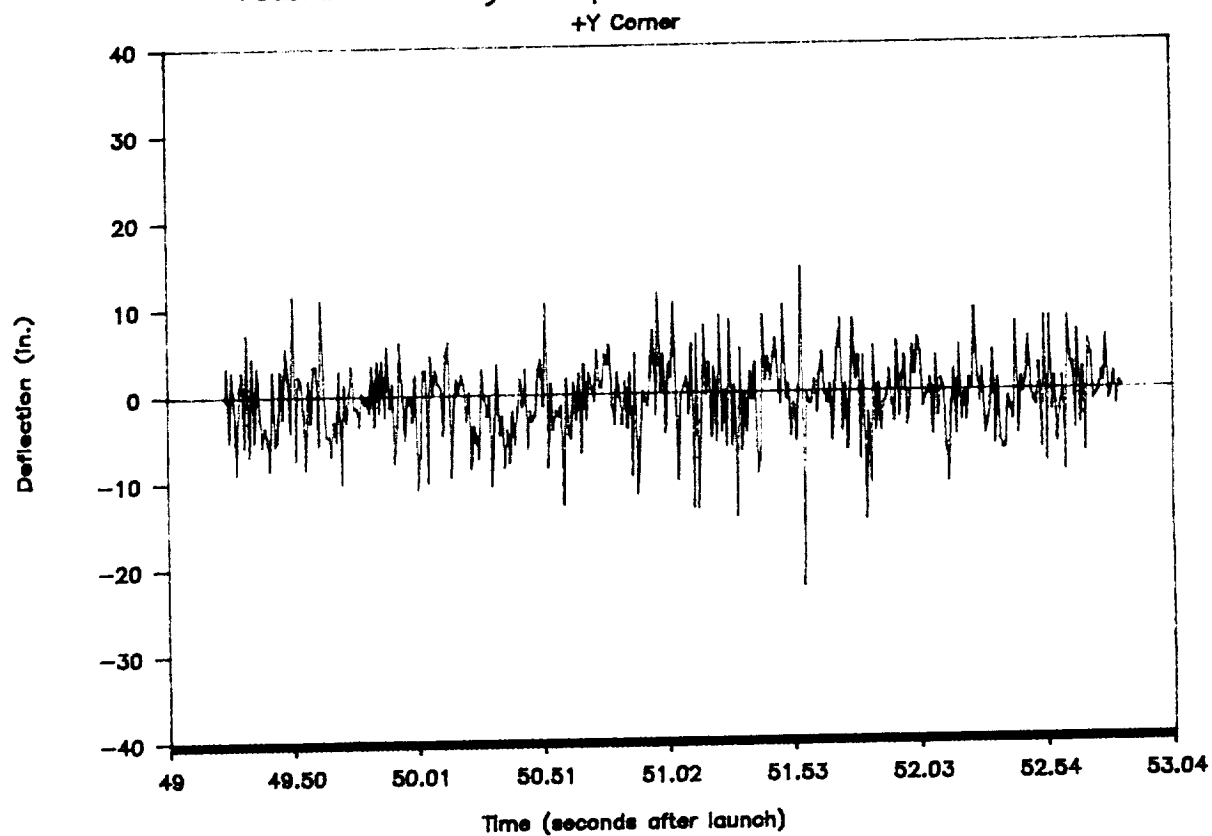
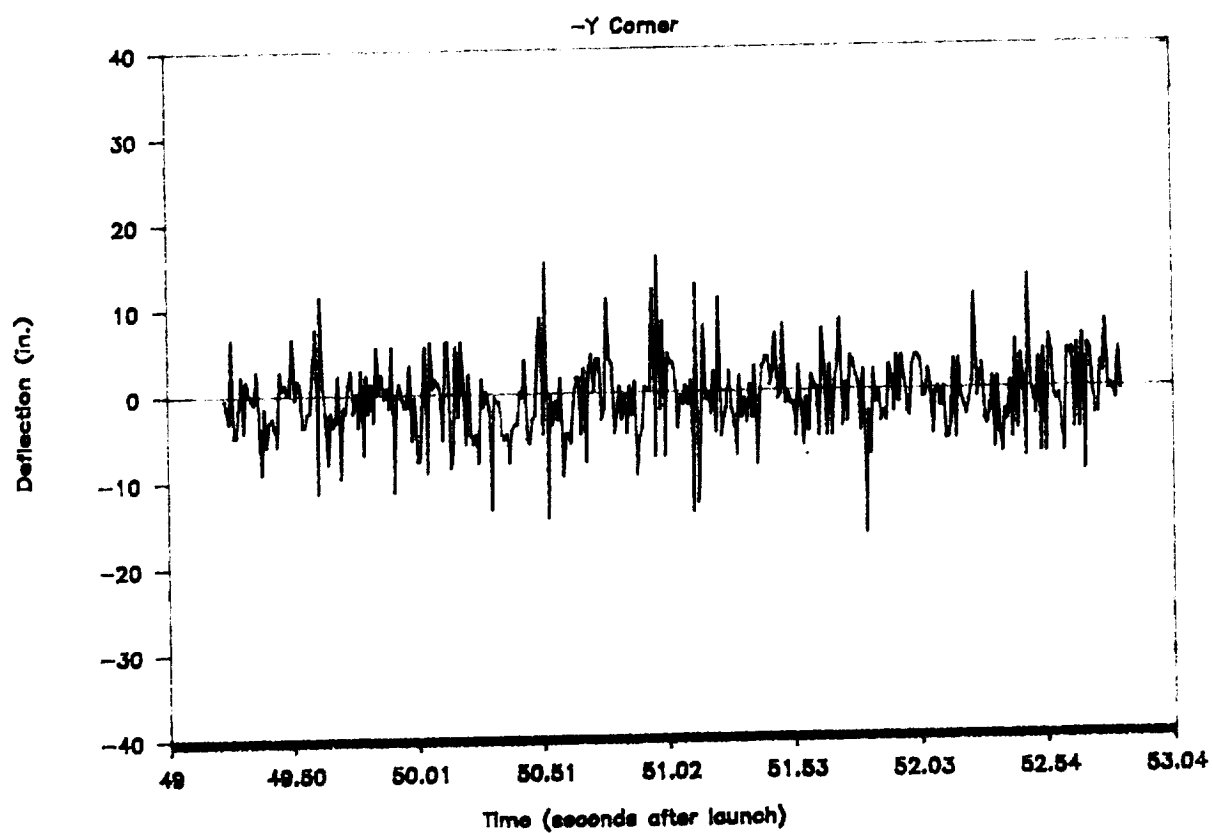
FIGURE 6. Body Flap Deflection

Movement of the Orbiter body flap was visible during the roll maneuver through most of the ascent (E-59, 207, 221, 222, 223). Maximum body flap deflections occurred between GMT 12:37:49.21 - 12:37:52.83 (Max Q 12:37:49.76). The amplitude of the deflections as measured from E-207 averaged 5.5 +/- 2 inches. The deflection frequency averaged 7.7 - 8.7 Hz (Figure 6).

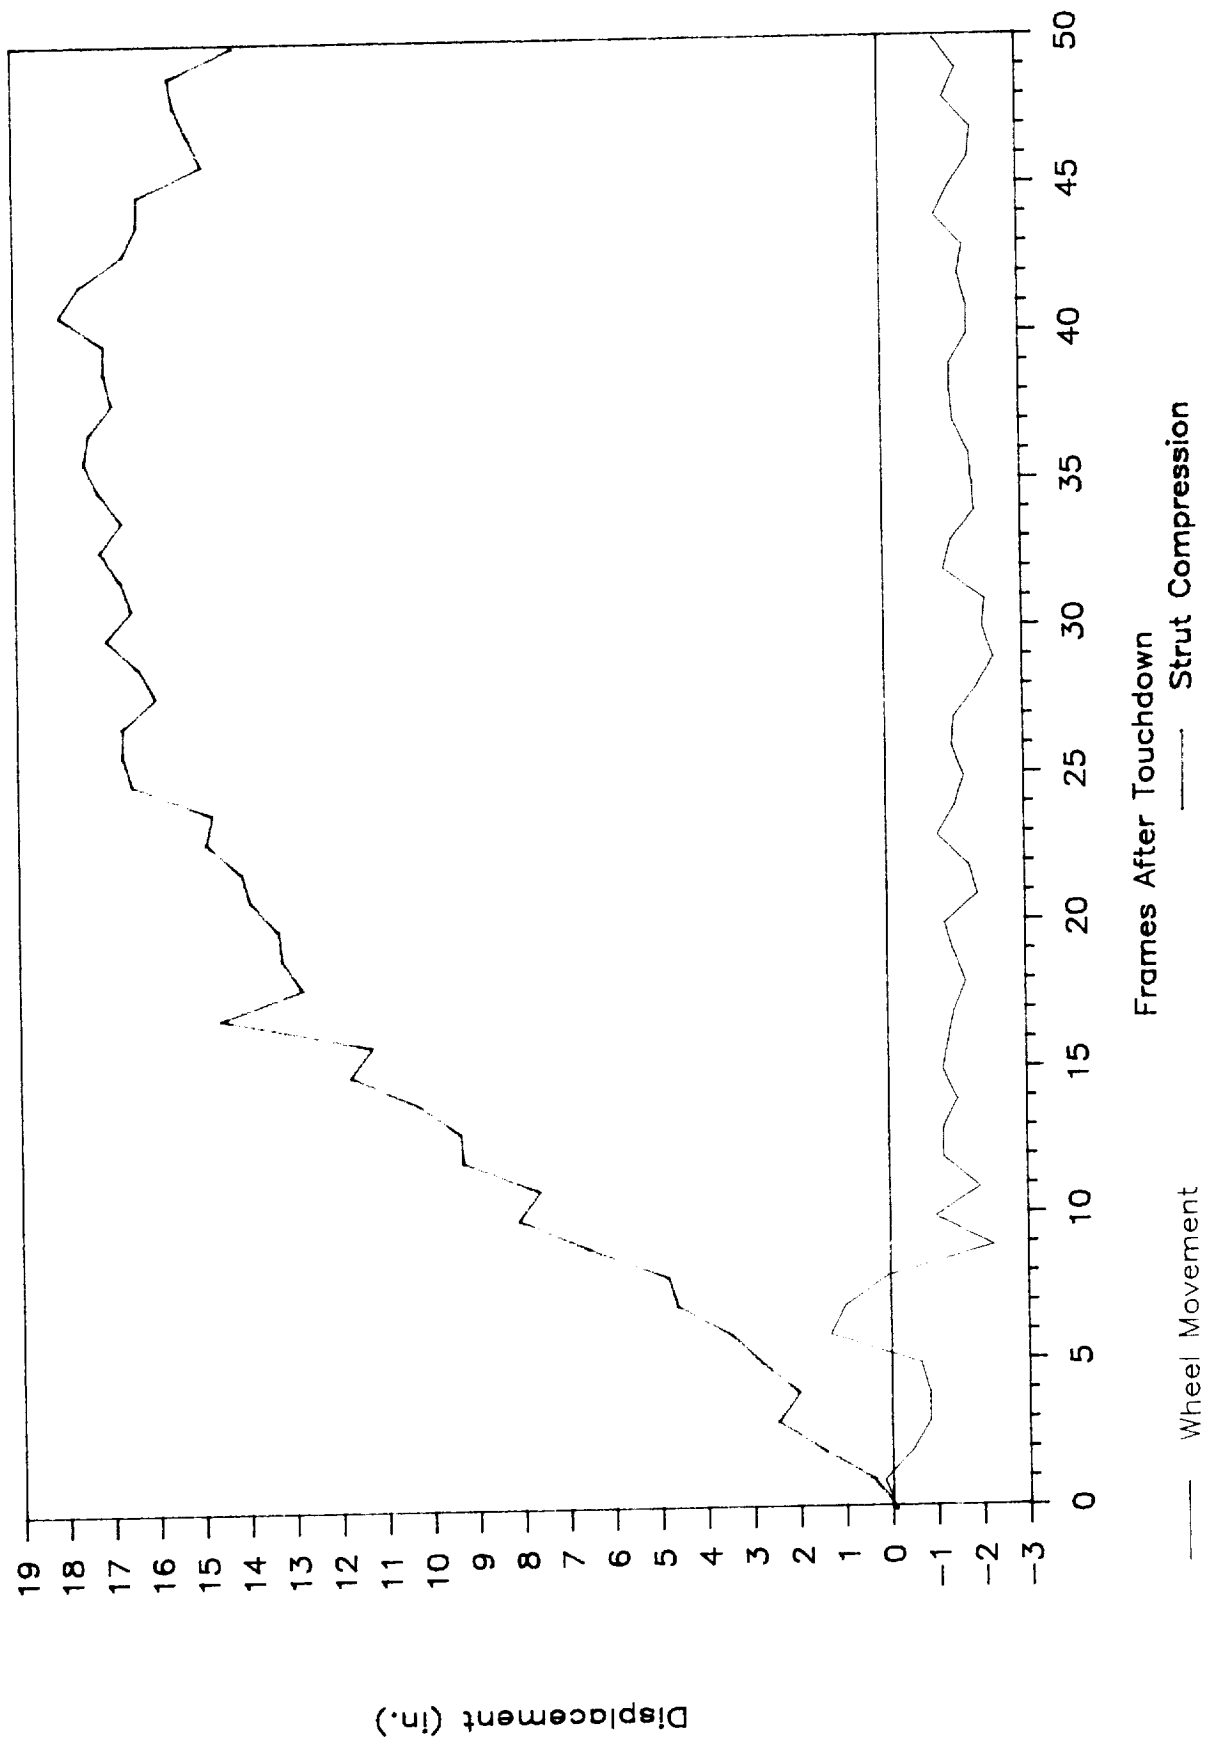
FIGURE 7. STS-28R Nosegear Deflection Study

one point, the body flap came within two feet of the runway surface. Due to low airspeed (154 mph) at main gear touchdown, nose sink rate was high and nose gear strut experienced significant forward/aft flex at first contact with the runway. The strut forward/aft flexure as measured on film item E-1001 was 1-2 inches and is graphically illustrated in Figure 7. The strut hydraulic stroke of 21.82 inches was close to the full or maximum stroke of 22 +/- 1 inch (all landing film items).

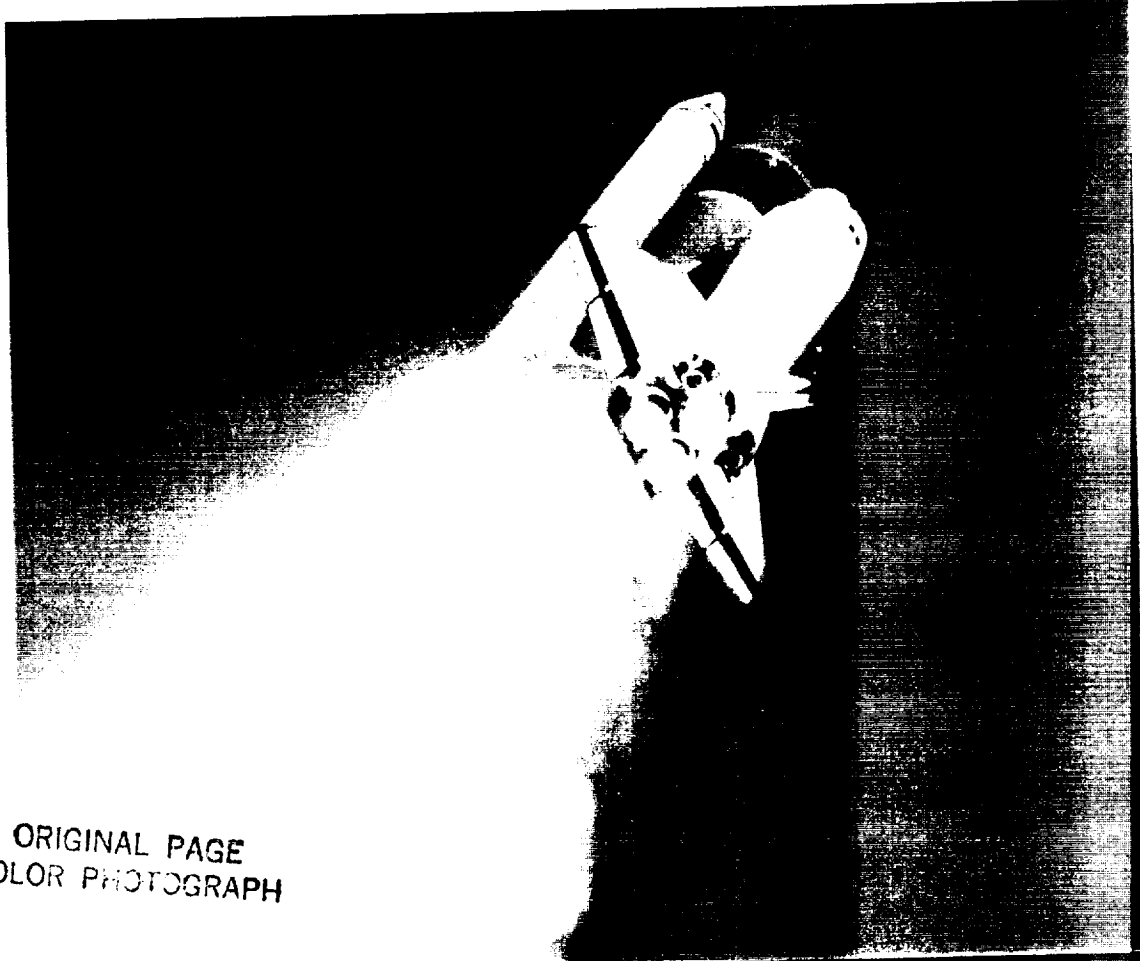
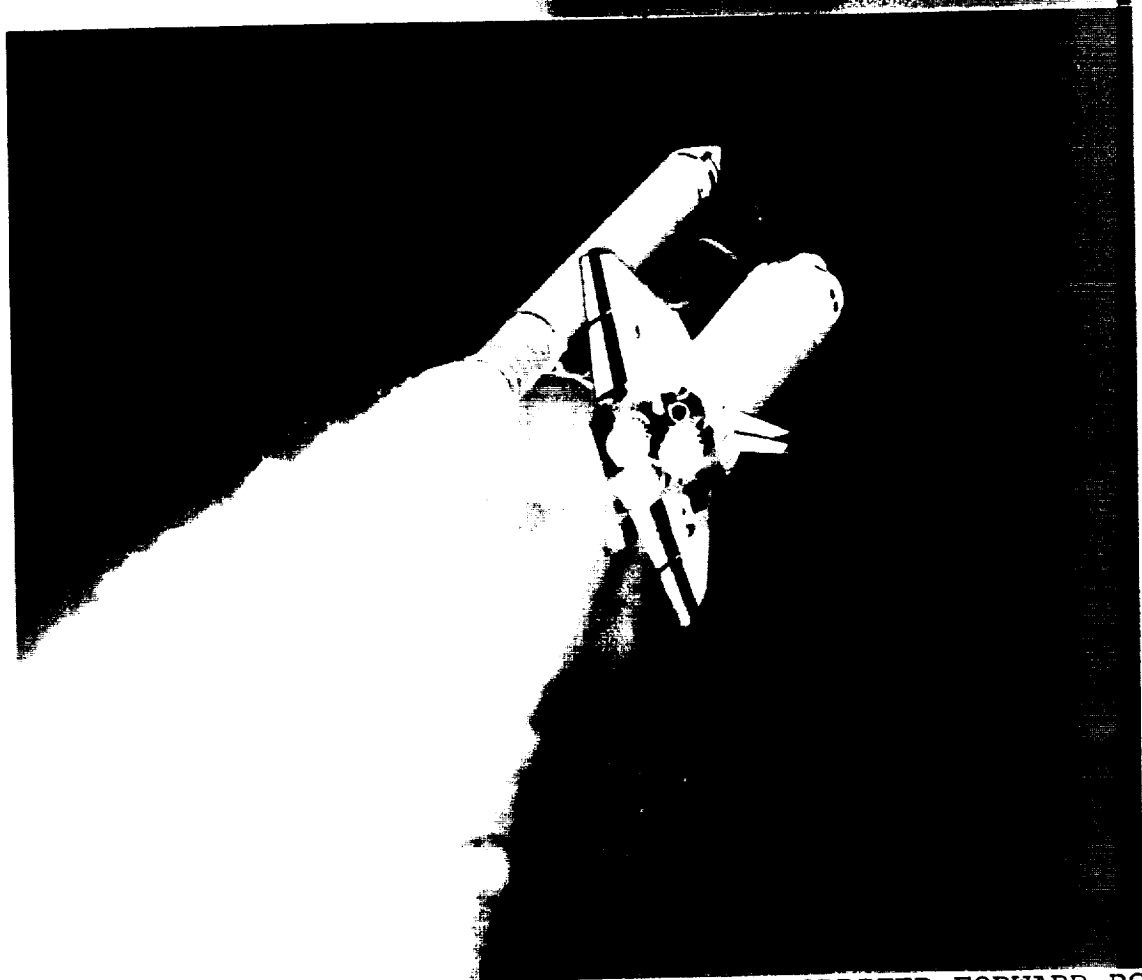
RED & WHITE COLORED PAPER COVERS FROM THE ORBITER FORWARD RCS
FALL PAST THE RH WING AND AFT OF THE VEHICLE
